Smart Energy Audit: House of Worship

Ramapo Energy Project

*A Project of Ramapo College of New Jersey
and the New Jersey Board of Public Utilities*

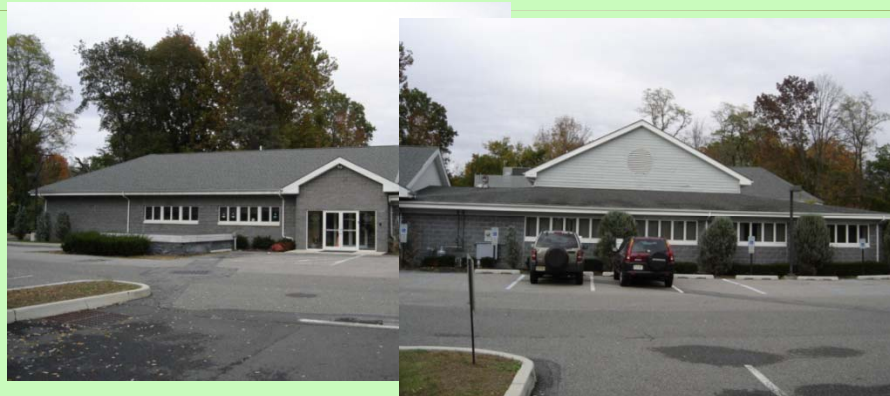
The Roof

- Roofs are angled (25° – 35°) and shingled
- South-facing roofs on Old and School wings

- The existing roof appears to be in good condition.
- ***The orientation and angle of part of the roof is excellent for adding photovoltaics. There is essentially no shading on the almost south-facing roof surfaces.***

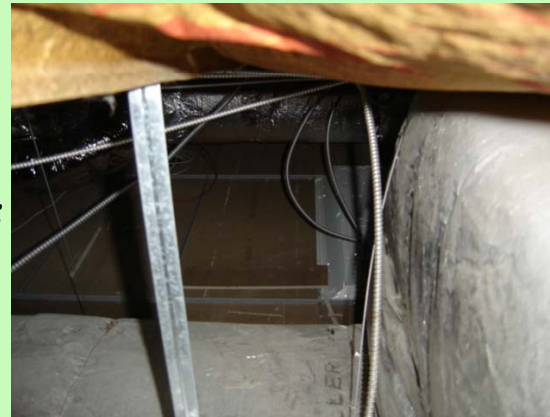
- It would appear that the Old Building has a **broken air barrier** that negates the value of the insulation and is very leaky. The two newer wings connect to this part of the building, both in the lived-in spaces, and above the ceiling. **The new wing's insulation is being bypassed by the air flow and is mostly ineffective. The suspended ceiling is the only barrier to the outside and it leaks air as well.**
- **Repairing this is the top priority for the building.**

very leaky. this part of spaces, and **insulation is and is mostly ceiling is the it leaks air**

- We suggest that you have a HVAC contractor examine the existing situation, and make recommendations for sealing and re-insulating as needed above the old building, and that the existing HVAC room above the janitor closet be isolated from the building, with outside air being brought in for combustion as needed.
- ***This is a high-priority and cost-effective action.***

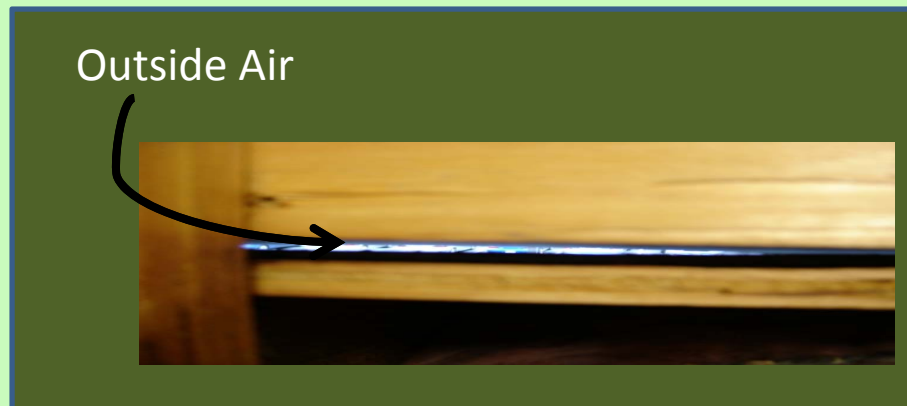
- A major problem for the building is found in the HVAC equipment room in the old building above the janitor closet. That space has many leakage areas directly to the outside, and there are many large connections to the inside of the building. ***The air leakage means that all the insulation is being bypassed as the warm air leaks through the suspended ceiling and other exit paths, around the the outside.*** out pulls other areas
- From what it appears and temple wings of the building have adequate thermal and air barriers. ***However, since all three parts of the building are connected through both the occupied areas and above the ceilings, the lack of a well defined air and thermal barrier in the old building is compromising the thermal integrity of the rest of the building.***

and then leaks insulation to
Warm air leaking cold air in from of the building.

we could observe, that the school

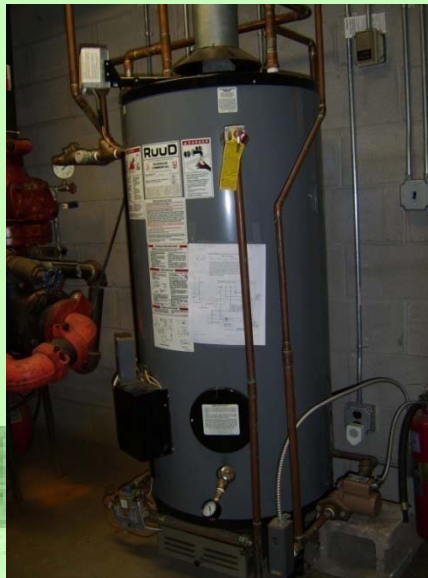
Hot Water Heater

- Natural gas
- 67-gallon tank, Ruud Model # RFD67-120-1 (Recovery: 109.1 GPH)
- Note: Although they have this hot water heating system, none of the checked hot water temperatures at faucets appear to be different from the cold settings. ***The system appears to be not working.***

- The gas-fired hot water heater appeared to be not working when we visited. Unit can be repaired and put on a timer.
- The hot and cold pipes on the tank should be insulated. The tank should be wrapped with additional insulation, taking care not to interfere with the burner and necessary air flow.
- Thermostat setting should be no higher than 120 degrees F.
- Insulation savings should be about 10%.
- Relatively low-cost one-time actions.

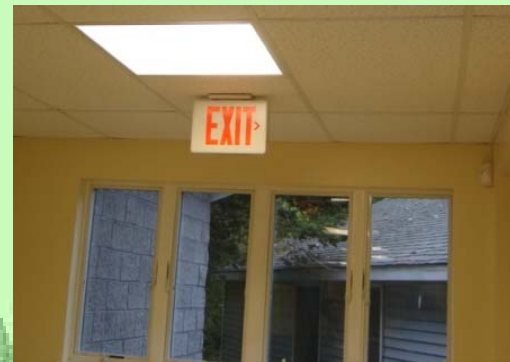
Exit Signs

- The exit signs should be replaced with LED lights and fixtures.
- Typical paybacks for this are 1-2 years depending on whether you are currently using incandescent or fluorescent lights.
- EPA Fact Sheet:
http://www.energystar.gov/ia/business/small_business/LED_exit_sign_tech.doc

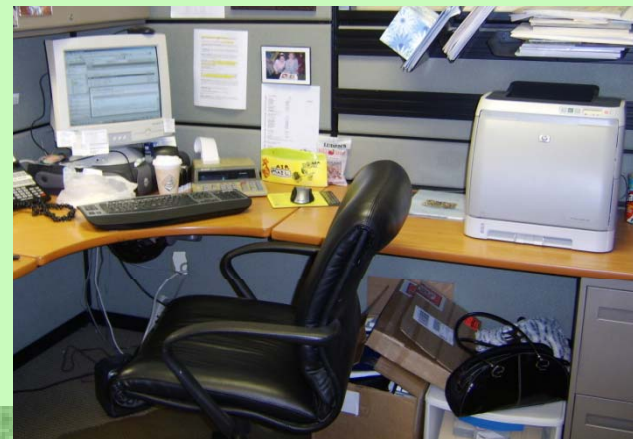
Computers

- Computers should be shut down fully when the building is closed. This can simply be done by putting them on power strips which are turned off when the building closes.
- To avoid unnecessary power use, computers can also be put in a “sleep” mode when not in use. Simple options in the computer’s Control Panel activate this feature.
- Isolated printers can be put on a separate power strip and turned on only when used.
- Computers not only use power, but they increase the air conditioning loads in warm weather. Thus, reducing unneeded computer power consumption brings substantial energy savings.

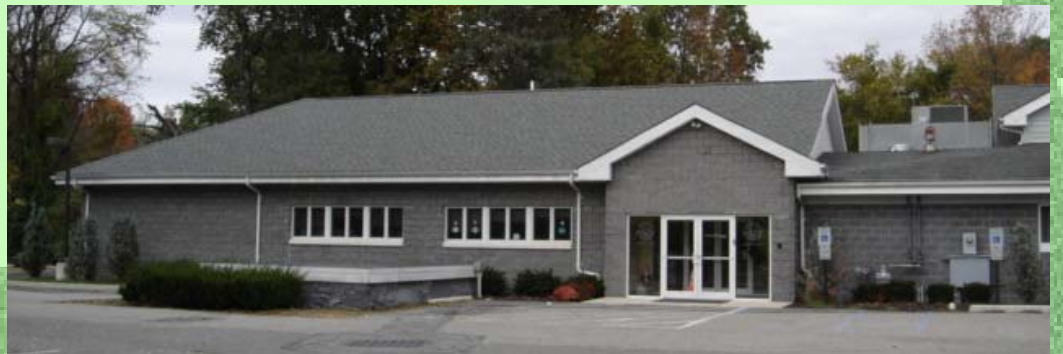
Roof A:

- 36 panels, totaling 6840 watts (190 watts * 36 panels)
- 12 columns, 3 rows
- estimated output: 8664 kWh/year
- estimated Carbon Dioxide Reduction: 12,427 lbs in first year

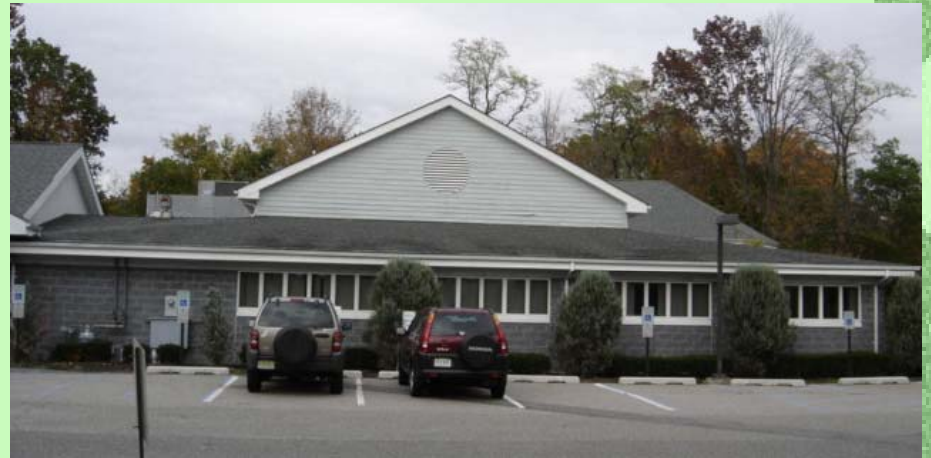
Roof B:

- 51 panels, totaling 9690 watts (190 watts * 51 panels)
- 17 columns, 3 rows
- estimated output: 12,003 kWh/year
- estimated Carbon Dioxide Reduction: 17,215 lbs (first year)
