# Smart Energy Audit: Library

Ramapo Energy Project

*A Project of Ramapo College of New Jersey  
and the New Jersey Board of Public Utilities*

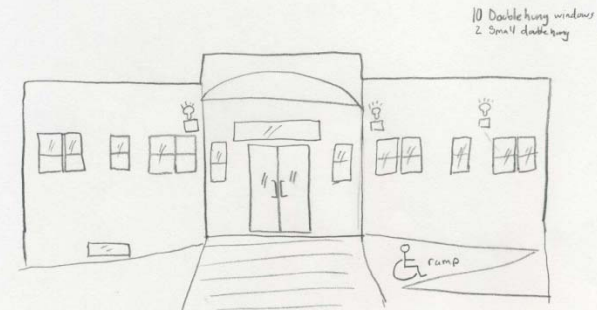
South East

South View of Building (Pay particular attention to potential south facing roof space, tilt angle, shading, type of roofing, uninterrupted space on walls, places for attached sunspace or GH):

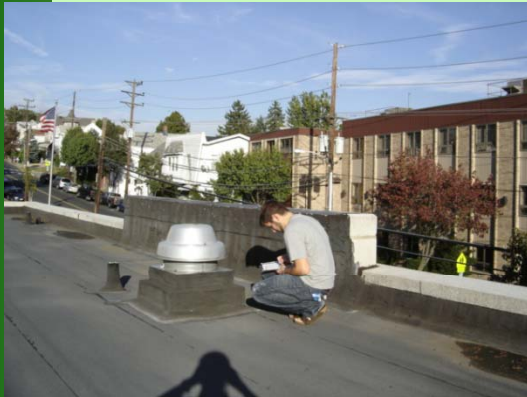
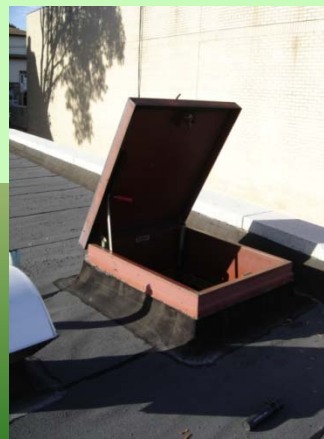
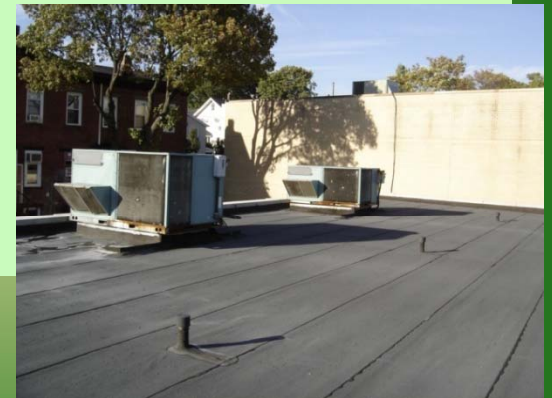
- 2800 sq. ft. roof is flat,, with rolled tar roofing
- 2 natural gas/electric Carrier HVAC units on the roof, and a roof ventilation fan.
- Uninsulated Bilco steel door entry to the roof , but with weather-stripping.

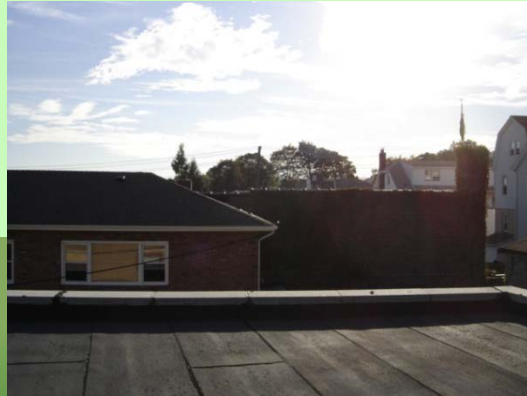
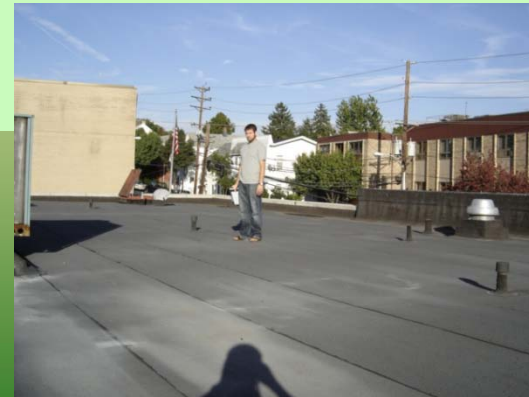
- Entire roof has good access to the sun. The Carrier units are on the NW side of the roof.
- There is a maple tree on the SE side, but it will be many years before it will shade the roof at all.

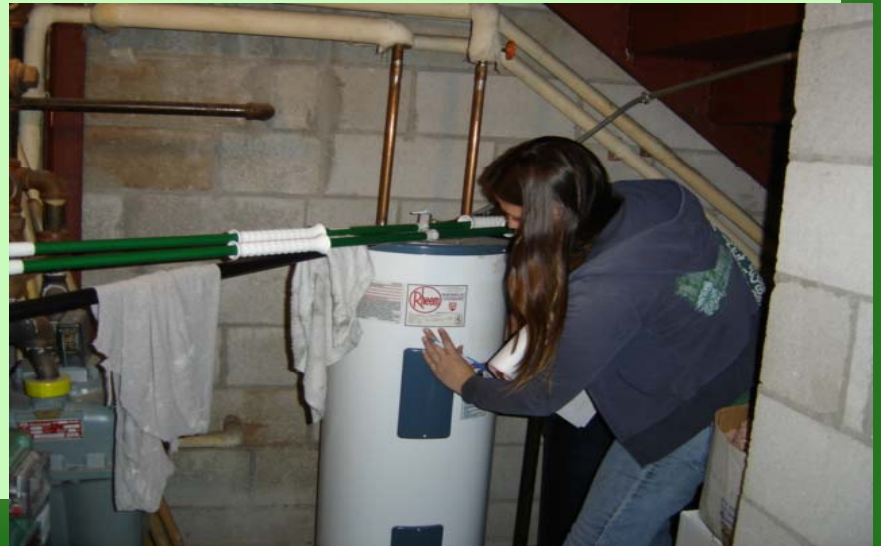
- 30 gallon electric hot water heater connects to bathrooms and kitchen. Model #: 81D30DB. The upper and lower resistance heaters are both 4500 watts. The hot and cold pipes that come out of the top of the water heater do not have insulation for the first few feet.
- The tank is not wrapped.

- The electric hot water heater can be put on a timer to provide service only during the library's hours of operation (provide a two hour lead time to make sure it's hot when the library opens).
- The hot and cold pipes on the tank should be insulated. The electric tank should be wrapped with additional insulation.
- Thermostat setting should be no higher than 120 degrees F.
- Insulation savings for tank and pipes should be about 10%. Timer will provide additional savings. These are relatively low-cost one-time actions.

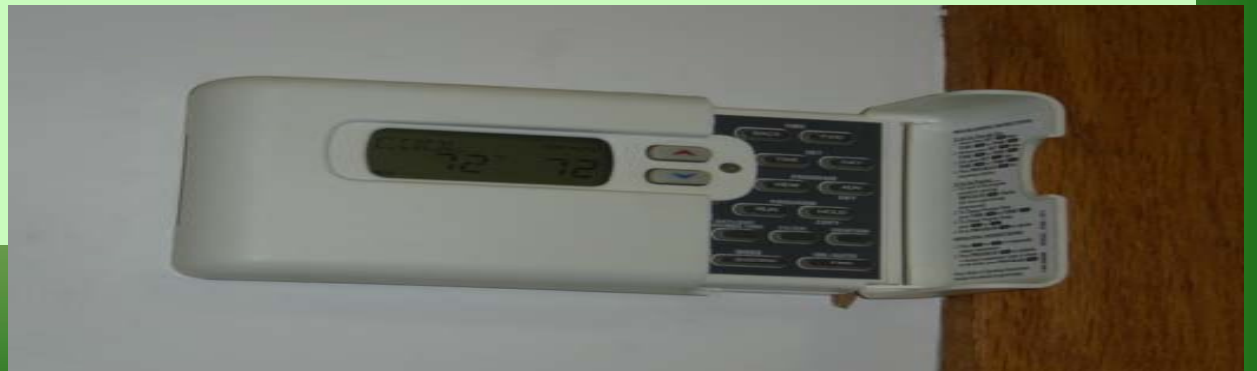
- Hot and cold air are distributed through air handling ductwork from the Carrier units on the roof. The ductwork is wrapped with insulation.
- Both HVAC units are controlled by programmable thermostats. There is a separate thermostat for each floor.

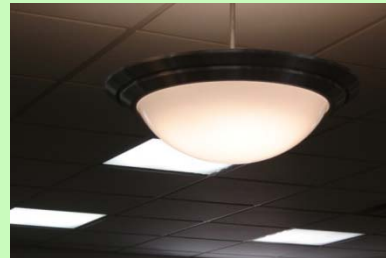
- The lighting in the room older than the rest of the 2-inch U tube lighting in could also be more

outside the kitchen is much lighting in the building. The the rest of the building efficient if replaced by

T8 or T5 fluorescent lights.

- We suggest getting an estimate from a lighting contractor that would include:

- measuring existing foot candle levels on working surfaces to see if intensities could be lowered somewhat, and
- providing estimates of cost and payback times for replacing existing fixtures with T8 and/or T5 fluorescent bulbs.

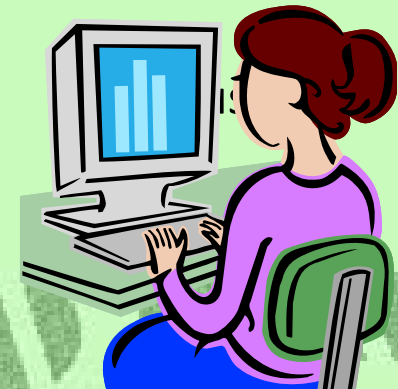
## *Computers*

- Computers should be shut down fully when the library is closed. This can simply be done by putting them on power strips which are turned off when the library closes.
- To reduce power use, computers can also be put in a “sleep” mode when not in use. Simple options in the computer’s Control Panel activate this feature.
- Isolated printers can be put on a separate power strip and turned on only when used.
- Computers not only consume electricity, but they also increase the air conditioning loads in warm weather. Thus, savings are substantial when computer power reduced.

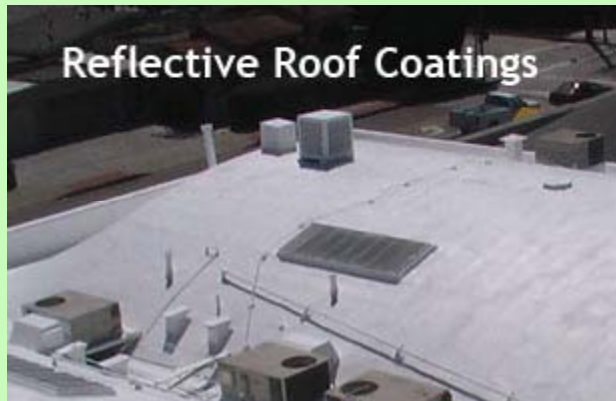
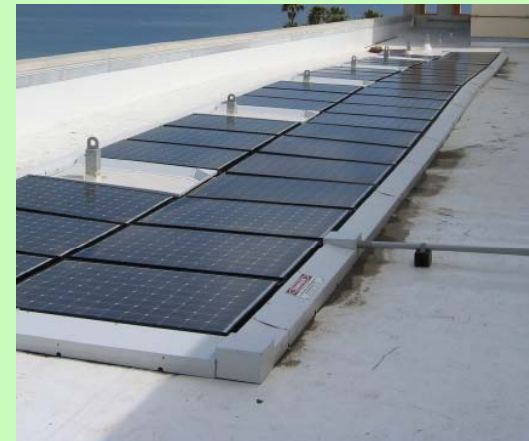
- The existing tar roof is in good condition. If that were to be replaced sometime in the future, you might consider adding insulation to the top of the existing roof, and then covering it with the new roof.
- At that time other options could be considered, including adding PV on top of the new roof or adding a white reflecting material that would reduce heat gain from the sun during the warm weather.

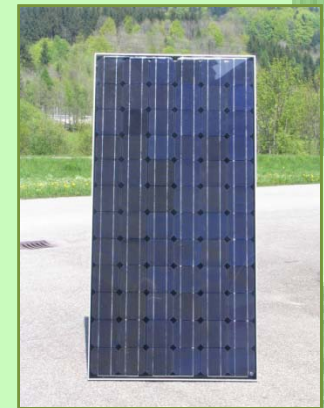
## *Photovoltaics*

- The flat roof has good solar access, and photovoltaic solar panels for electricity could be installed on part of the roof, either in flat configuration or in a tilted configuration. However, most other recommendations in this list should be implemented before this one since their payback times are likely to be a lot shorter.
- The roof has good solar access for solar hot water. However, given the minimal use of hot water in the library, this is not recommended at the present time.
- ***A detailed PV analysis follows...***

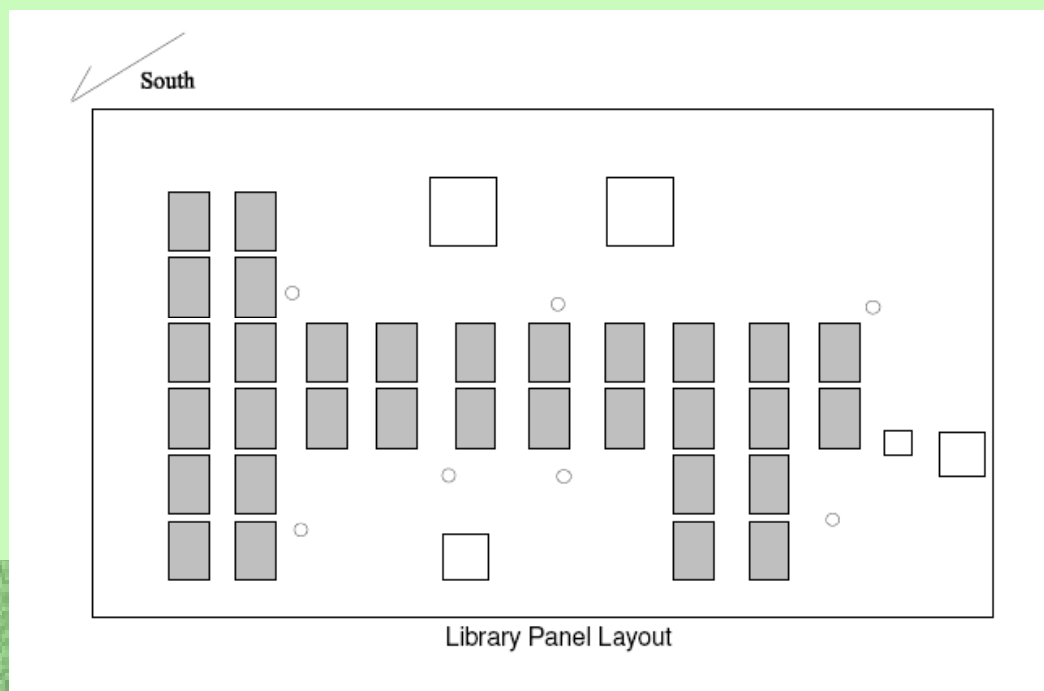
## Library Panel Layout

Array Shading Analysis: With the array shape as designed, shading will be at a minimum

Usable Array Size: About 650 sq. ft.

Array Direction: South West

- 10 degree tilt
- mounting system:
- no penetrations into roof
- 32 panels, totaling 6560 watts (205 watts \* 32 panels)
- panels in landscape mode
- low profile rack with ballast
- assumes roof can handle up to 10 lbs per sq. foot
