Smart Energy Audit: Office

Ramapo Energy Project

*A Project of Ramapo College of New Jersey
and the New Jersey Board of Public Utilities*

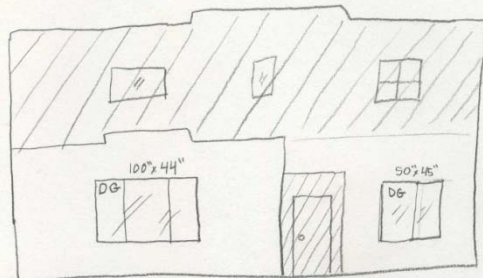
Orientation of Building (Include window and door location as well as vegetation and shading; indicate outdoor lighting fixtures):
North View of Building:

DG = New double Glazed

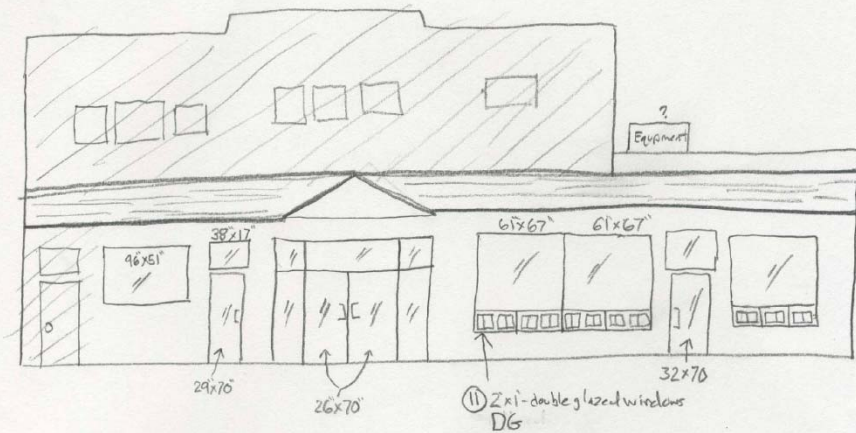
South View of Building (Pay particular attention to potential south facing roof space, tilt angle, shading, type of roofing, uninterrupted space on walls, places for attached sunspace or GH):

South East

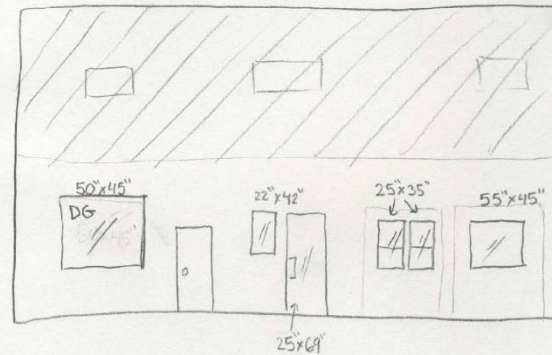
North West View of Building:

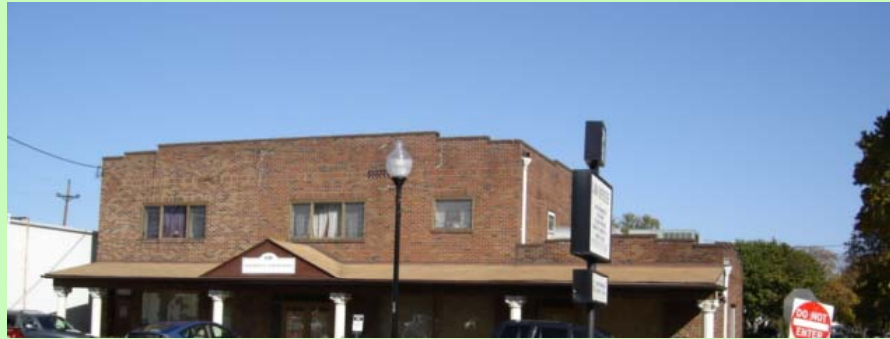
- There is no solar blockage of the building roof (flat) and the overhang roof across the front of the building.

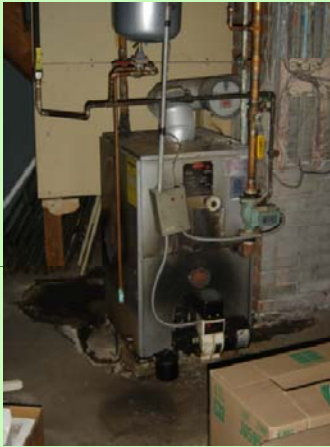
Oil-fired heating unit for apartment on the SE side, providing both hot water and baseboard heat. This is located in the basement in the one story building. Hot water for the bathrooms in the law offices is also obtained from this unit. There is very little hot water use by the law office.

- The existing oil boiler for heat and hot water is likely very inefficient, particular when only used to provide hot water in the warmer weather. The aquastat setting should be reduced from 190 degrees F to a lower, but still acceptable ,setting.
- A solar hot water heater, coupled with an electrical backup, might be a possible alternative for hot water production (see below).

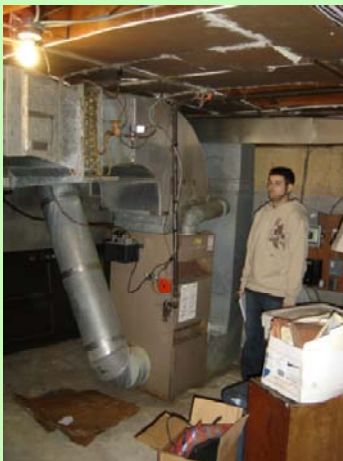
Heating and cooling gas-fired system is for both the law office library, and one apartment located in the 2nd floor. This unit is located in the basement below the 2nd story building.

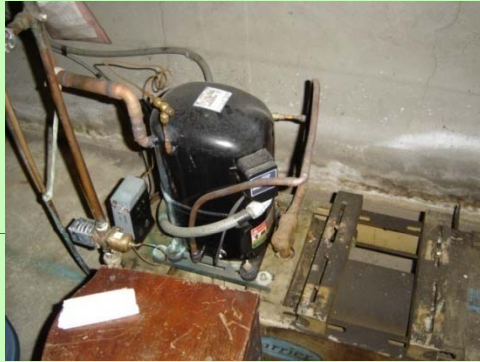
Compressor unit is located next to the furnace in the previous picture. There is a heat exchanger in the ductwork associated with this unit.

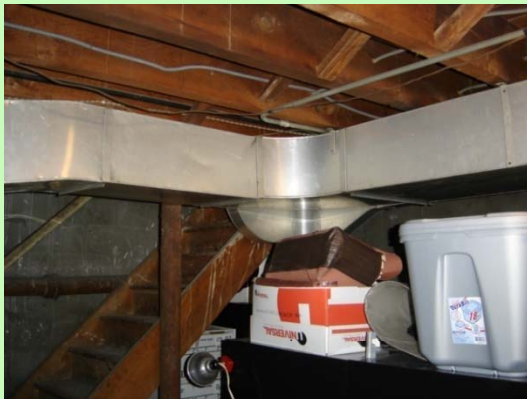
Ductwork from the natural gas fired heating and cooling unit in the basement below the two story part of the building. It is not insulated.

- The GE forced hot air, natural gas heating system has un-insulated duct work in the basement. This duct work should be insulated. The duct tape which seals the duct work together is old and should be replaced with mastic or aluminized tape. There are also some small holes present in this duct work which should be sealed with the mastic as well. These are relatively low-cost one time actions.
- The hot and cold pipes on the hot-water tank should be insulated. The tank should be wrapped with additional insulation, taking care not to interfere with the burner and necessary air flow.

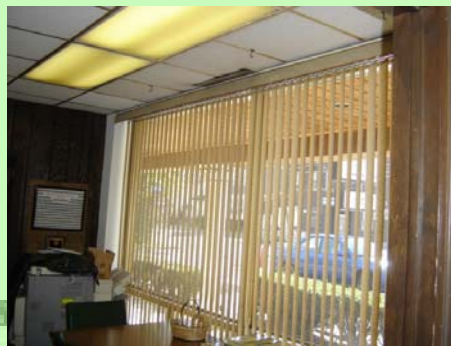
- There are a large number of windows that are single-glazed, particularly facing the main street, causing a large heat loss during winter months, and a large heat gain during summer months. The most cost-effective way to reduce these losses is to replace the existing, single-glazed windows with gas-filled, double or triple pane windows with a low-E coating. Also (see below) , creating a sunspace/vestibule on the front of the building can reduce heat loss and also provide solar heating.

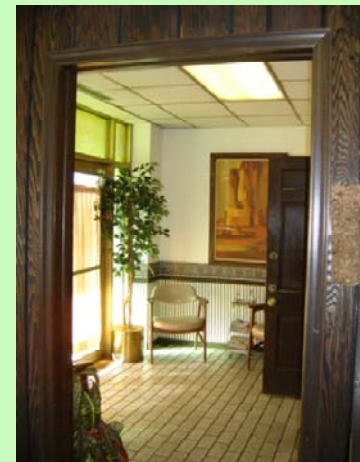
- There is no vestibule at the entrance of the building which allows the cold air from the entry door to blow directly into the client waiting area and surrounding offices, significantly lowering staff and client comfort, as well as causing a significant heating (and cooling) energy loss.
- This problem can be solved by adding a small glass-based or plastic-based vestibule to the front of the building entrance which would mitigate cold air entry as well as gain useful solar energy in the winter to help keep itself warm. By keeping its construction back two feet from the existing overhang, the vestibule will be shaded in summer to avoid overheating.

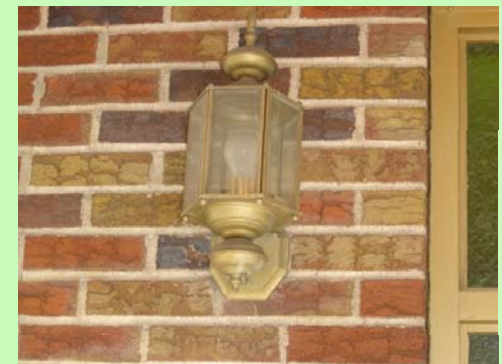
- The conference room and library are used on and off throughout the day depending on scheduling. A conscious effort should be made to turn these lights off when the rooms are not in use, or to put them on a heat or movement sensor control.
- Outside lighting can be put on a light-sensor control rather than a timer, and the most efficient bulbs can be installed.
- Inefficient lighting not only increases power usage, but the waste heat generated increases air conditioning loads in the warmer weather when prices for electricity are the highest. Improvements in this area thus provide multiple and substantial energy savings.

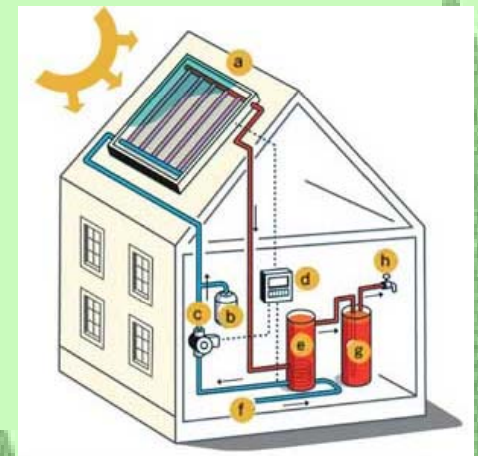
- The upper-level flat roof has good solar access for solar hot water. Since the office owner is also the owner of the apartments above the office, this is an option the owner should consider.
- For the two apartments and the office hot water needs, a solar hot water system consisting of 2-3 panels and an 80-120 gallon storage tank would likely suffice. This system would produce about 75% of the hot water needs over the year. .
- There are state and federal tax credits and deductions that significantly reduce the cost of this option. (See the Smart Energy Audits website for links to up-to-date information on credits, rebates and subsidies)
- Payback times are typically 6-10 years depending on the existing energy source and the hot water price.
